Client: HAP
 Carlton/Eastwood
 Project: Carlton/Eastwood
 Location: Portland, Oregon
 G2 Project #: 1011-27

Eastwood Ct. and Carlton Ct. Modernization
 Carlton - 5249 NE Killingsworth St. Port., OR 97218
 Eastwood - 18210 SE Yamhill St. Port., OR 97236
 Projects No. RFB 01/10-96
 Asbestos Abatement - Ceilings

Asbestos Abatement - Floors

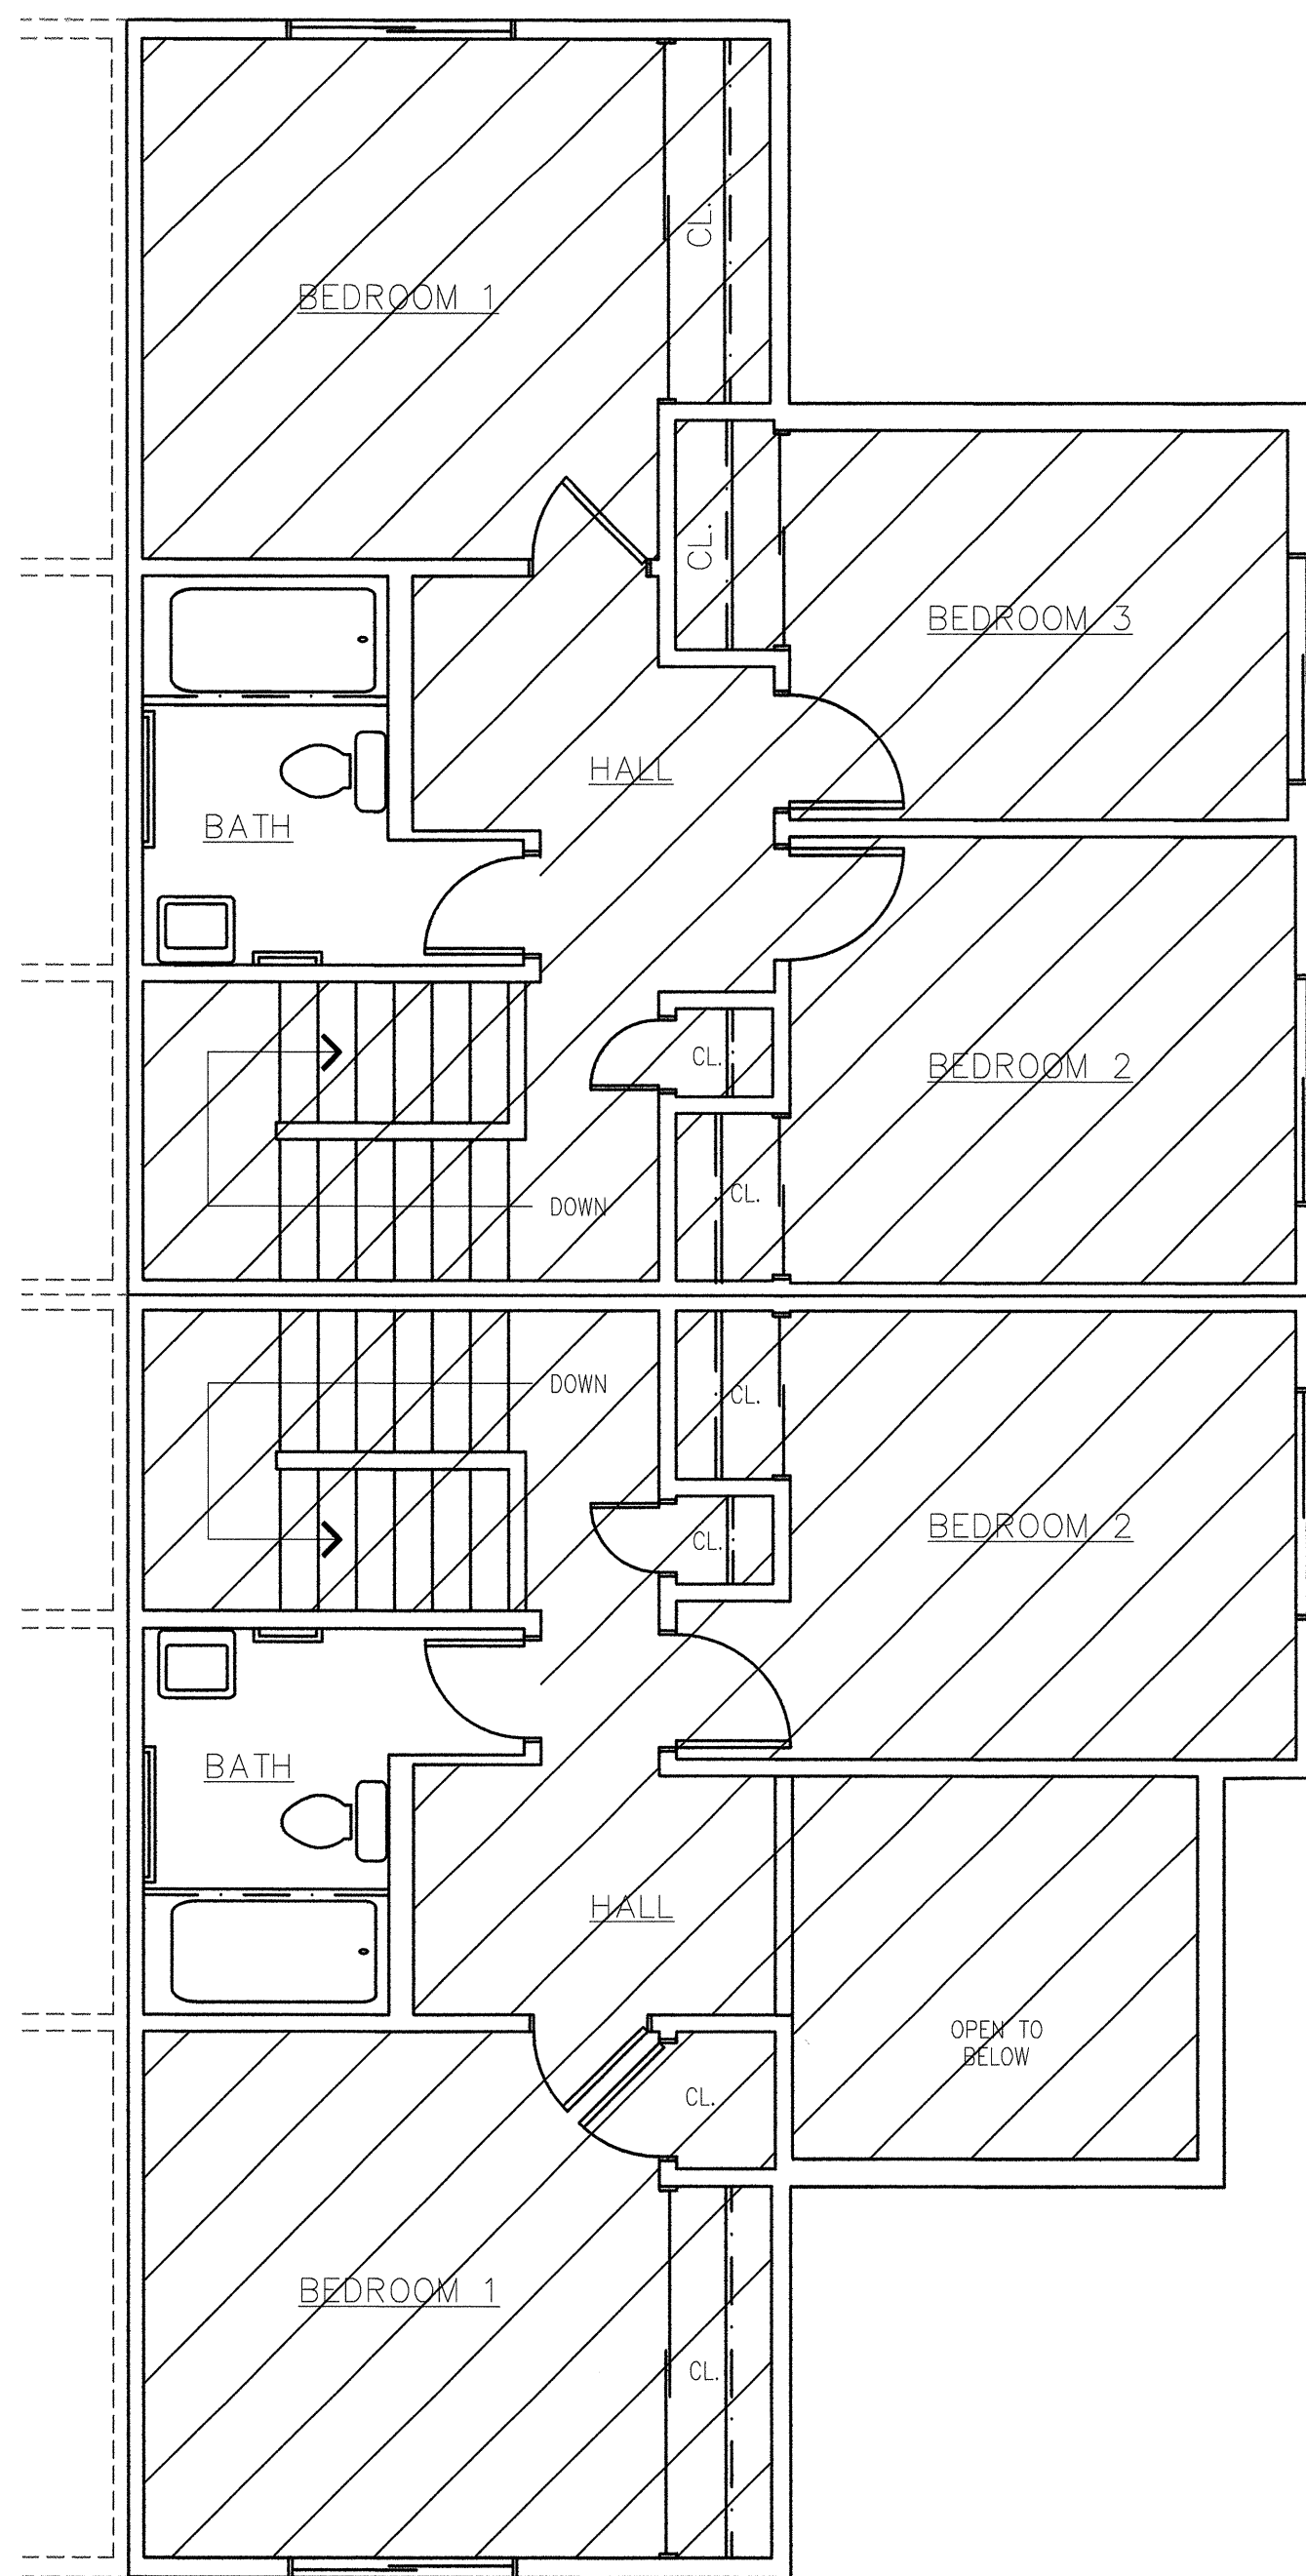
1 TYPICAL SECOND FLOOR PLAN - EASTWOOD CT.
 ASB-1 SCALE: 1/4"=1'-0" FOURPLEX

Asbestos-Containing Ceiling Texture on Drywall

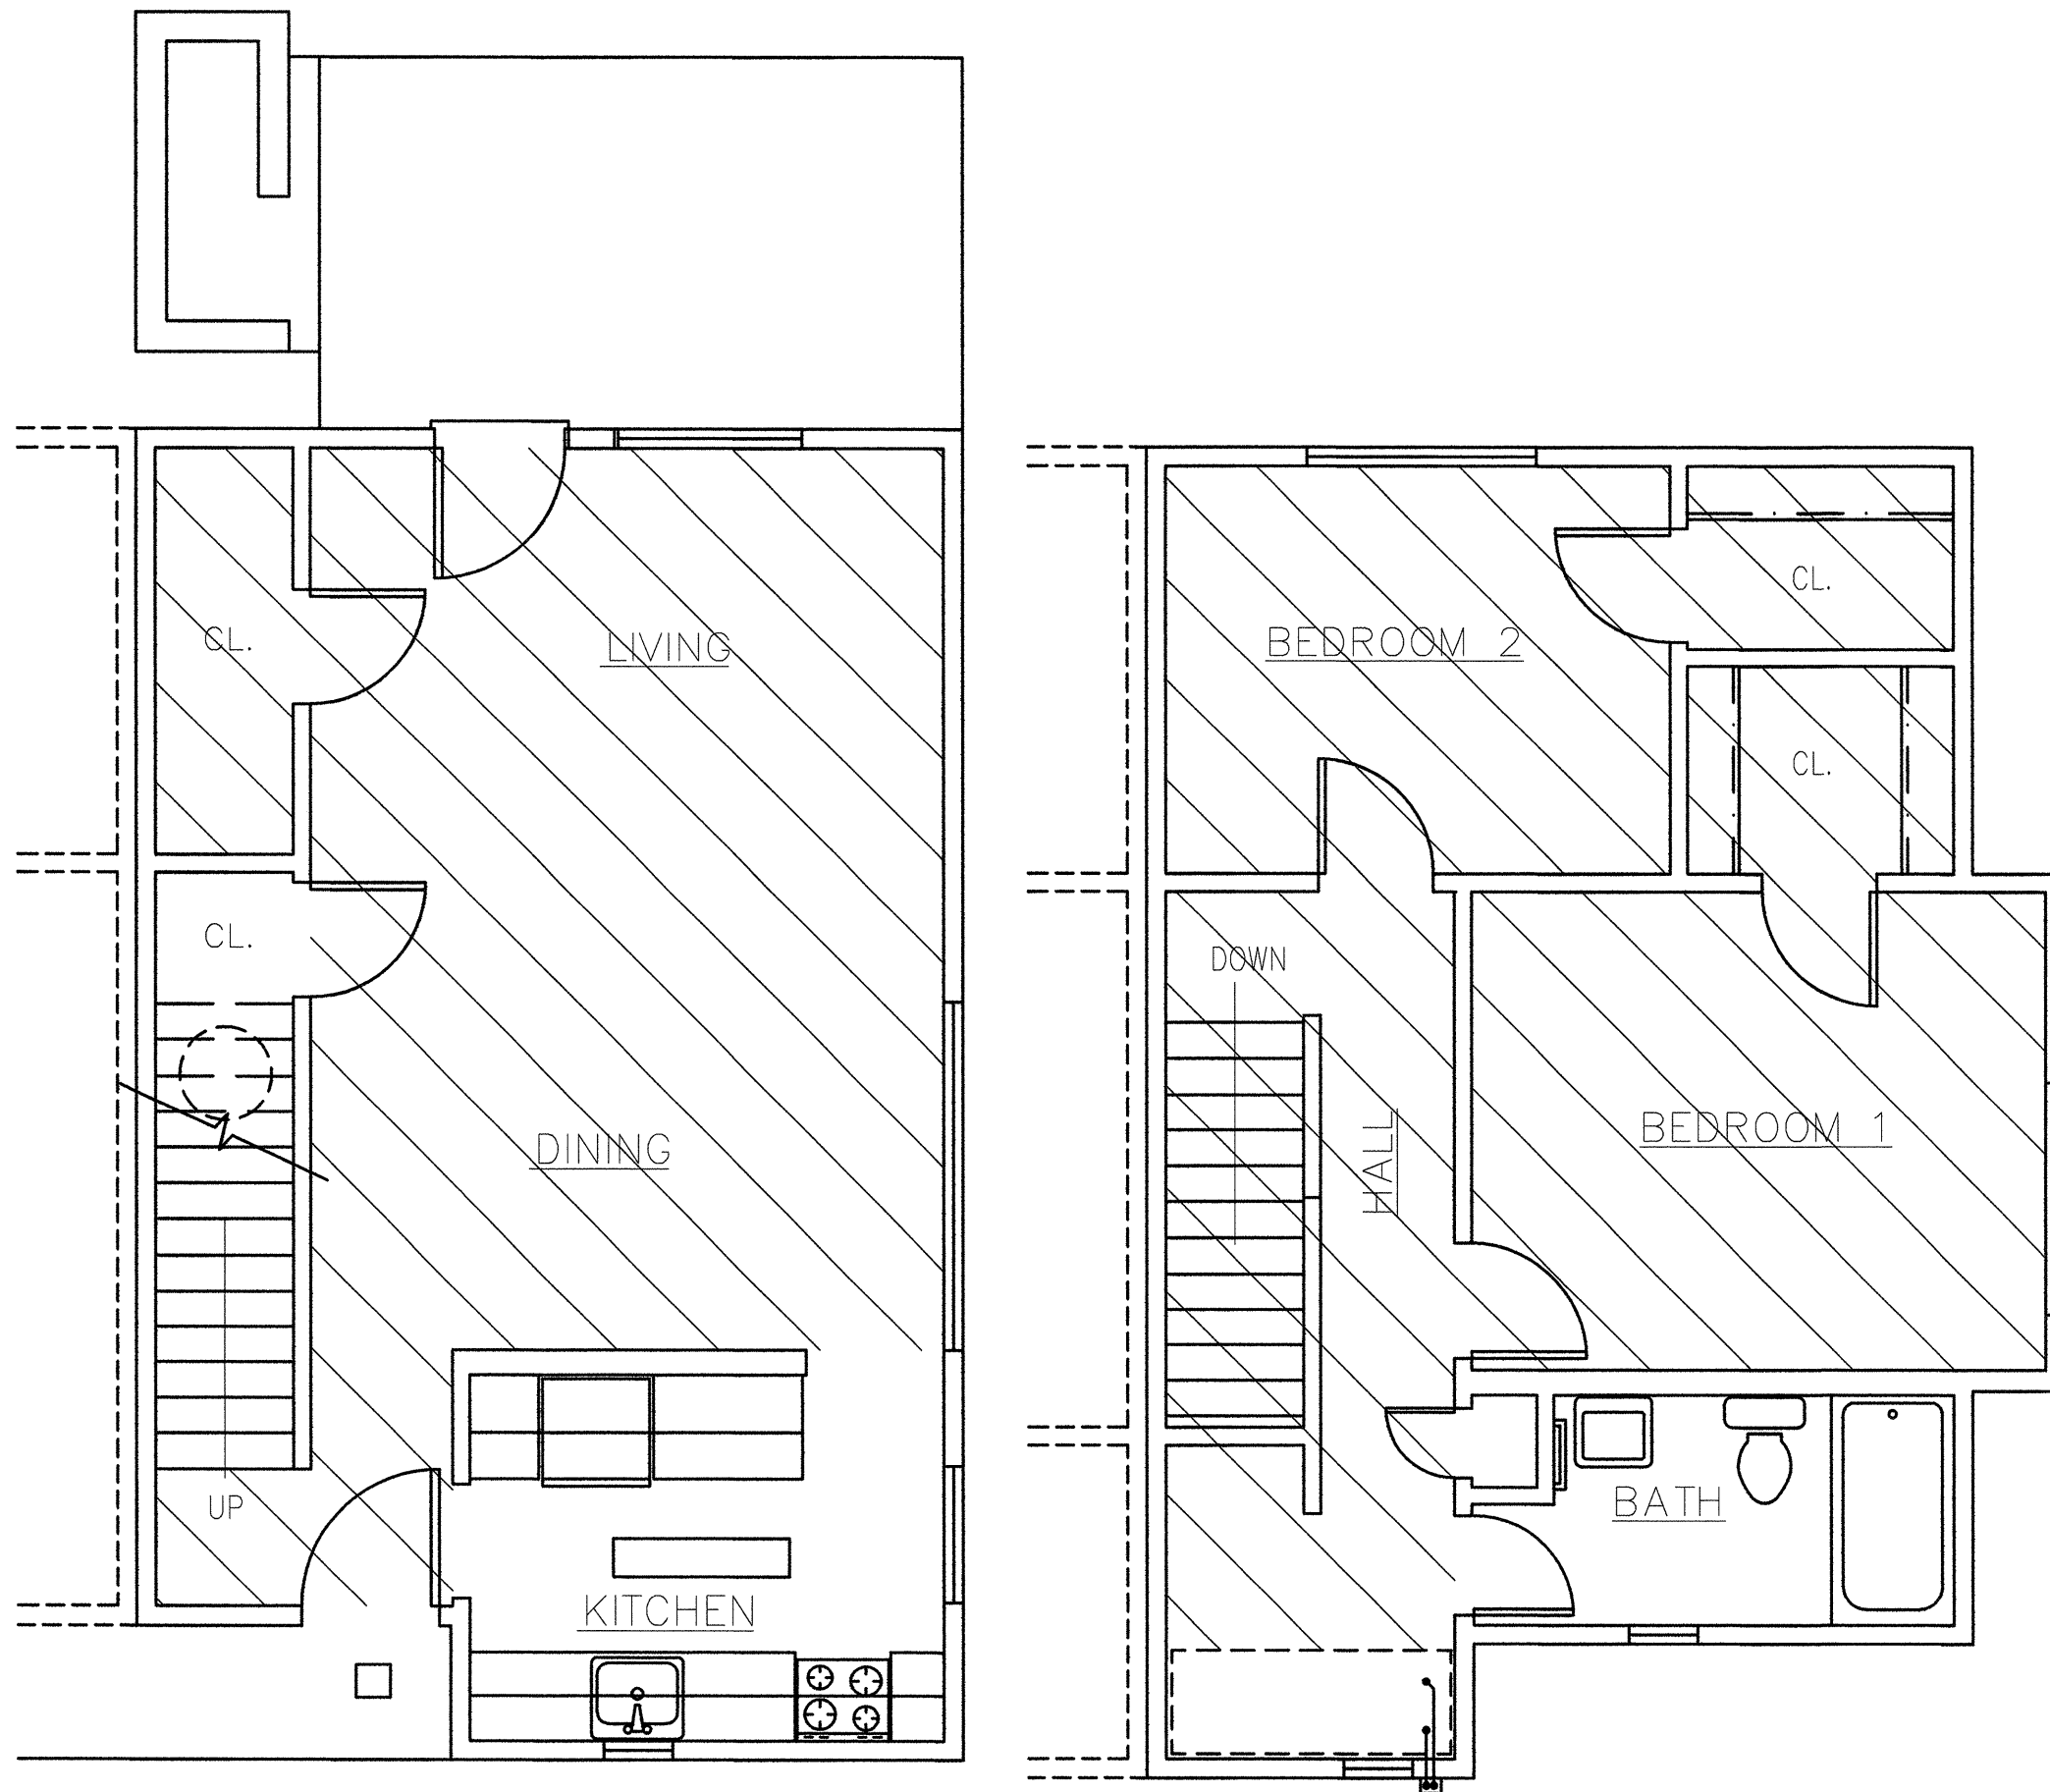
1 EASTWOOD COURT DUPLEX
SCALE: 1/4"=1'-0"

Asbestos-Containing Ceiling Texture on Drywall

- SCOPE OF WORK - CEILINGS:**
1. Removal and disposal of approximately 710 sq. ft. of asbestos-containing ceiling texture on drywall substrate from the duplex unit.
 2. Removal and disposal of approximately 685 sq. ft. of asbestos-containing ceiling texture on drywall substrate from the ADA unit.
 3. Removal and disposal of approximately 400 sq. ft. of drywall w/ asbestos-containing joint compound from the duplex units to provide access for new plumbing and electrical runs.
 4. Removal and disposal of approximately 500 sq. ft. of drywall w/ asbestos-containing joint compound from the ADA unit to provide access for new plumbing and electrical runs.
